Rudderstock refurbishment and protection

Application:	The rudderstock made of forged steel, suffering from bimetallic corrosion in the area between the liners/seal boxes and below the steering gear
Place:	FA Yard, Denmark
Date:	July 2019
Job and report done by:	Breki Ship Service ApS
Wencon products used:	Wencon Rapid & Coating

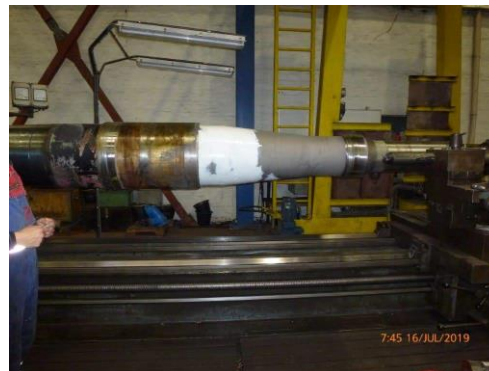
Application of first layer of Wencon Protective Coating White in progress

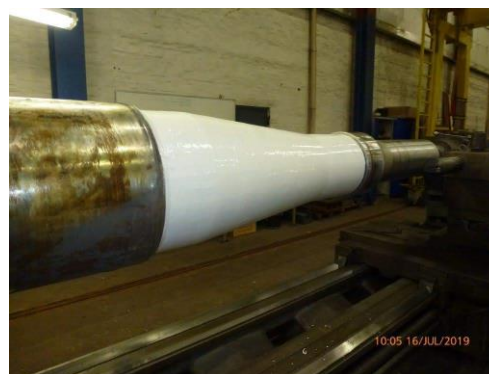
Application of first layer Protective Coatings White completed

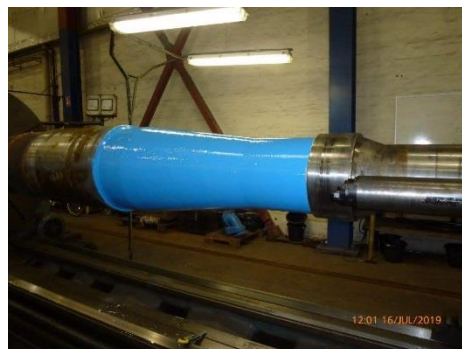
Protective Coating Blue completed

Please note that the transition liner/rudderstock is now sealed and eliminates the risk of penetration of the surrounding media, and thereby excluding the risk of corrosion damage and loose liners etc.
