### Rebuilding of Stern Boss flange

Job executing contractor: Gemak Shipyard

Report done by: PI-ES Marine AS

Date: 29.06.2020

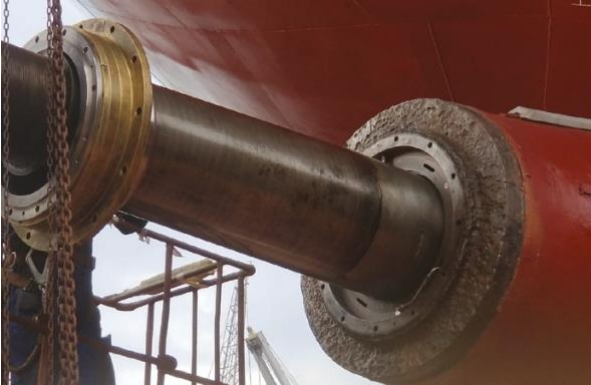
Due to bimetallic corrosion the Stern tube Boss Seal Surface has been damaged and required by Class to be reconstructed / recovered.

1. Rope Guard removed.  
Oil drained and propeller dismantled.  
Stern tube seal box and flange ring has been protected with rubber gasket a plastic tape before blasting.  
Stern boss corroded parts have been grit blasted to SA 2½ / 75 µm.
