Cooler end cover, corroded

1.
Emergency repair of cooler end cover from the outside, to stop the leakage.

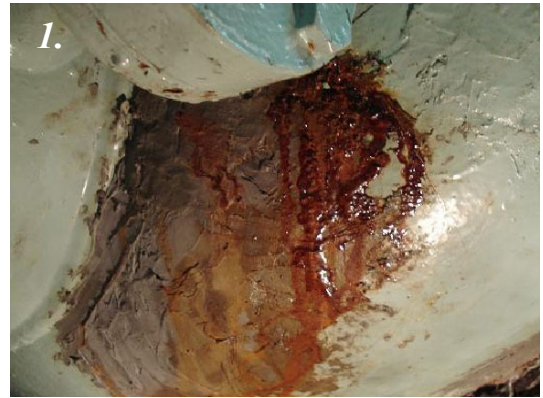
2. & 3.
Surface cleaned with Perago Disc and Wencon cleaner to achieve a rough surface, for a good adhesion of the Wencon material.
Wencon UW Cream was applied, due to dripping water and adhesion on a wet surface was needed.

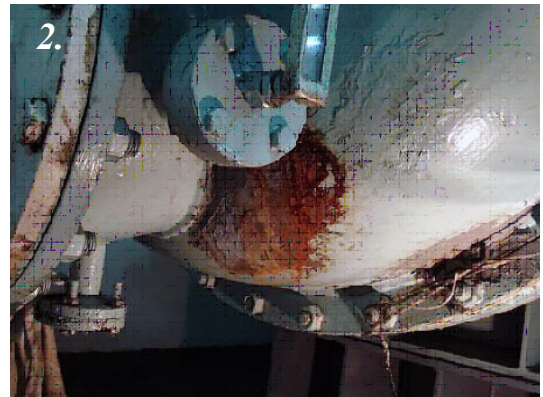
A small spot slowly dripping was discovered after ended application. Presumably caused by pressure on the end cover from the inside. Wencon recommended to add some extra layers of Wencon UW Cream on top, to stop the leakage completely.
