## Rebuild of Thruster Gear Housing

<b>Application:</b>	Refurbishment of Thruster Gear Housing.
<b>Place:</b>	Rotterdam, NL
<b>Date:</b>	January 2011
<b>Job and report done by:</b>	CC World Wide / Repair Management, NL
<b>Wencon products used:</b>	Rapid, Coating white, Coating blue, Cleaner, appl. tools.

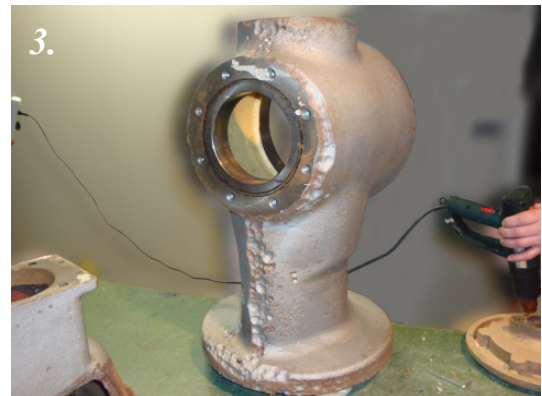
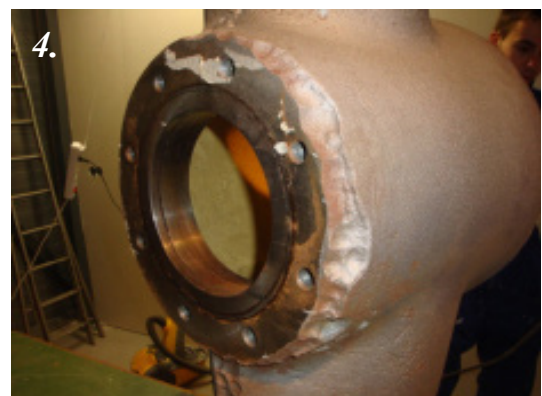
3 & 4.

Unit blasted shortly, before commencing application, ready to clean using Wencon Cleaner.

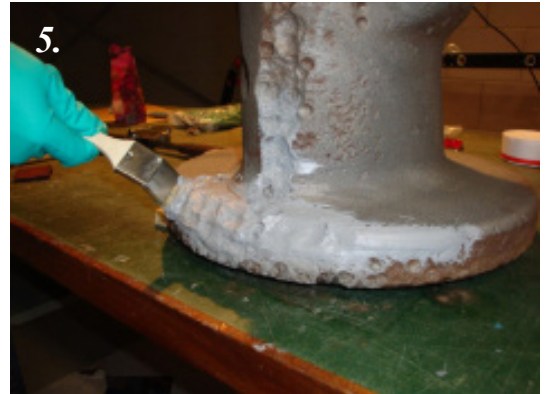
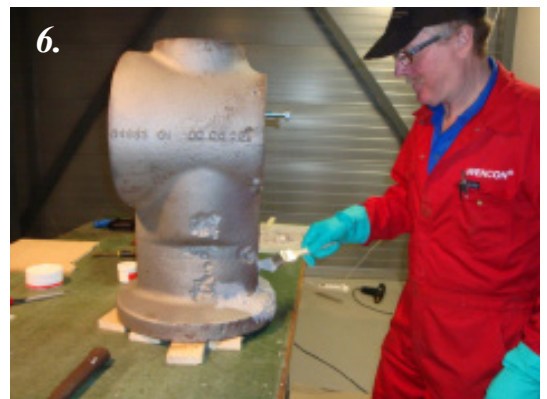
5. & 6.

The damage is very deep and therefore brush is used. This is to ensure that Wencon Rapid is in contact with the metal, in even the deepest holes and corners.

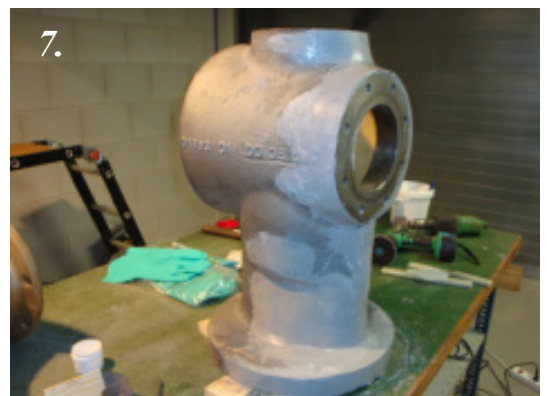
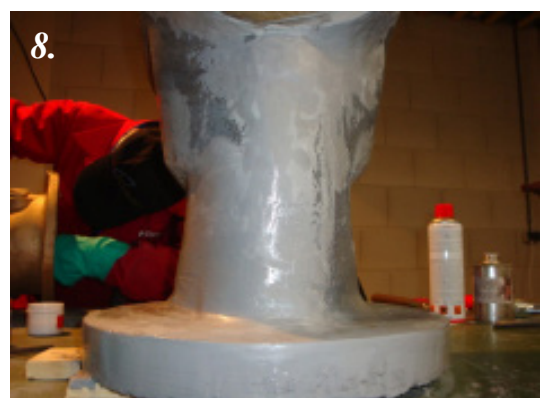
7. & 8.

Using a spatula, the housing is rebuilt layer by layer to original shape. Wencon Rapid exhibits many of the characteristics of metals, which together with outstanding adhesion to all metallic surfaces, makes the repair compound highly suitable for repair of corroded and worn metals.

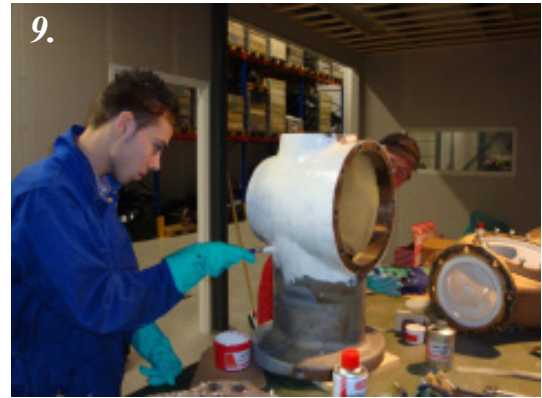
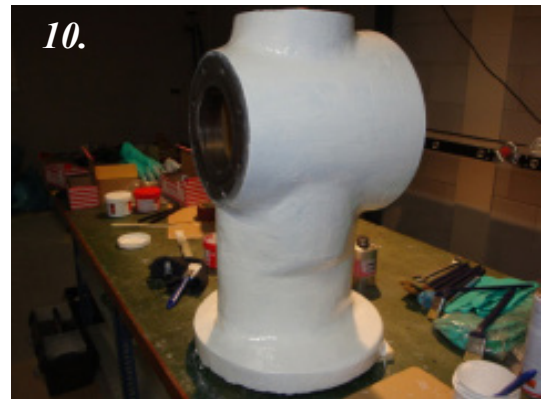
9. & 10.

To avoid similar damage in the future, it is decided to protect the unit against corrosion using Wencon Coating in a two layer system. First layer, applied with a brush.

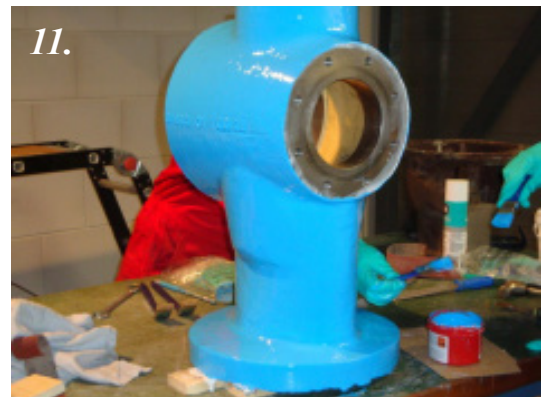
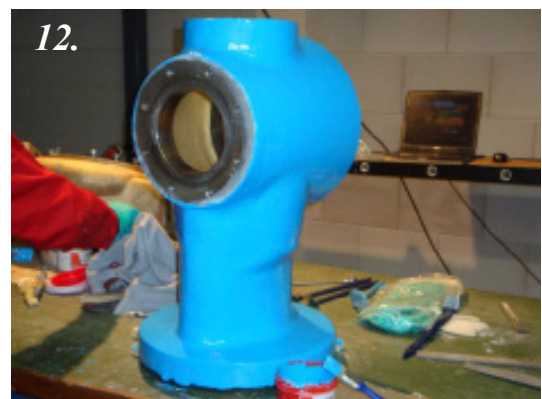
11. & 12.

Second layer also applied with a brush.

Wencon Coating offers resistance to oil, water, saltwater and most diluted acids and alkalis as well as a range of solvents. Heat resistance ranges from 60° C (140°F) in corrosive and heavy load environments and up to 250° C (482°F) when applied as a filling compound.

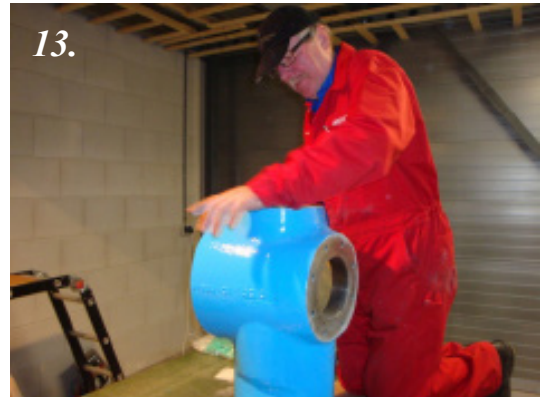
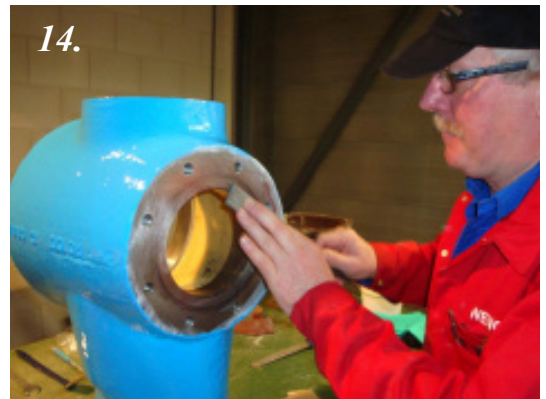
13. & 14.

After curing over night, only the after works remains. The Wencon materials used at this job can be machined, drilled and worked like metal, after curing.

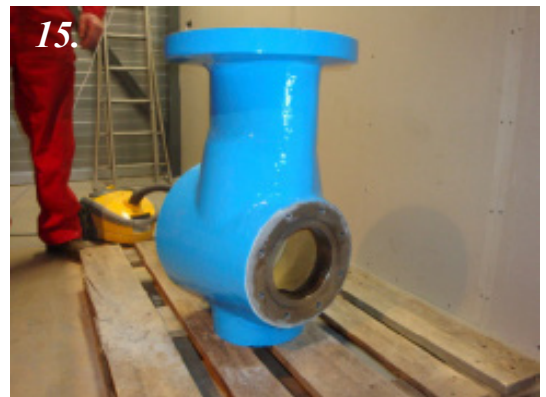
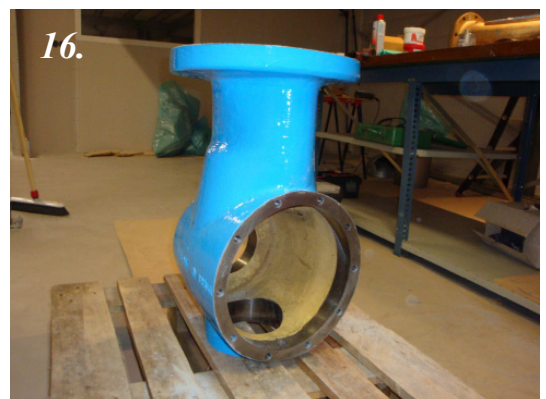
15. & 16.

Note the contact surface, which was heavily damaged; is now rebuild to original shape.

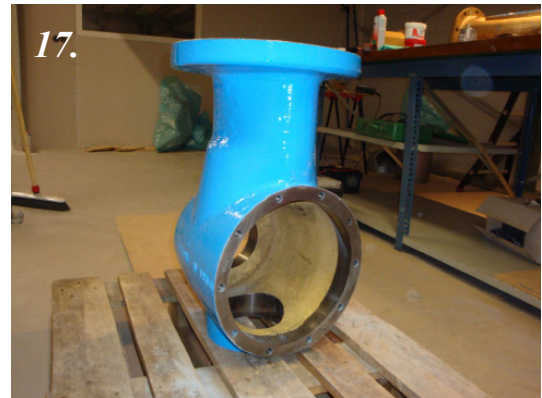
17.

The steel is now separated from the seawater, and will not be attacked by bimetallic corrosion for many years. It is better protected than a new unit.
