## Cast to fit of rudder pin bearing house

**Place:** Piraeus Drydocks, Greece

**Date:** June 2009

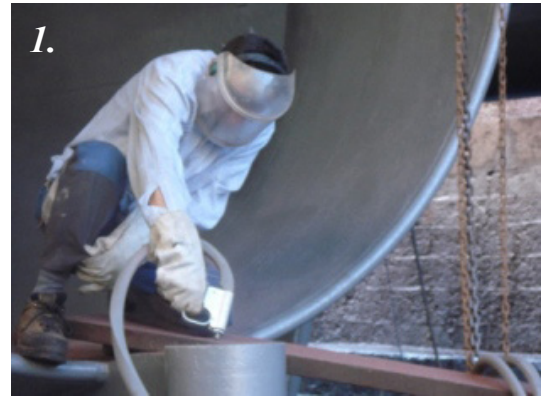
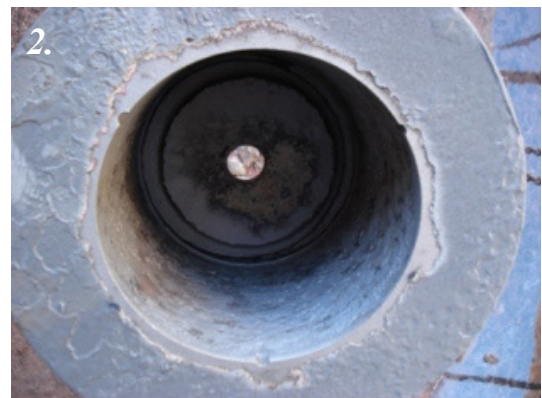
1. & 2.

Blasting of bearing housing using Wencon Blaster.

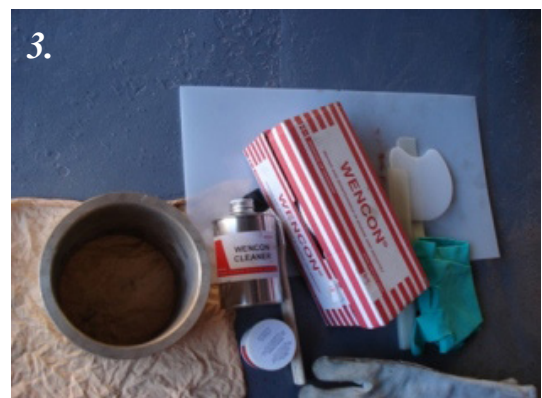
3. Cleaning of bearing housing using Wencon cleaner.

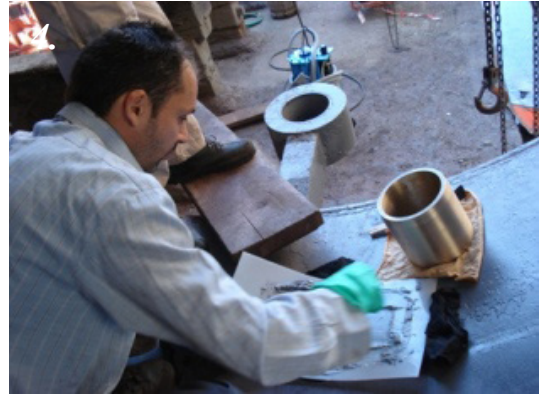
4. Apply Wencon Release Agent on the outside diameter of the bronze bearing.

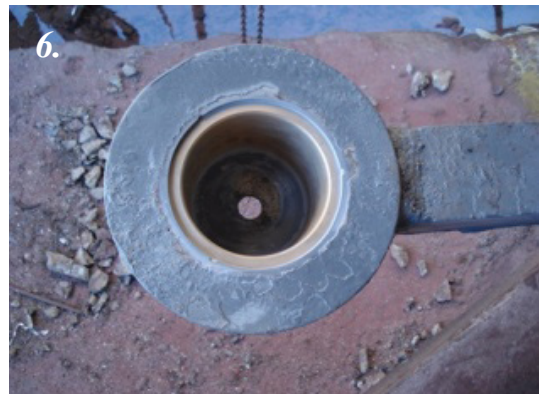
6. Assembly of the bearing into the bearing housing.
