Ballast Valve casings

1, 2, 3 & 4.

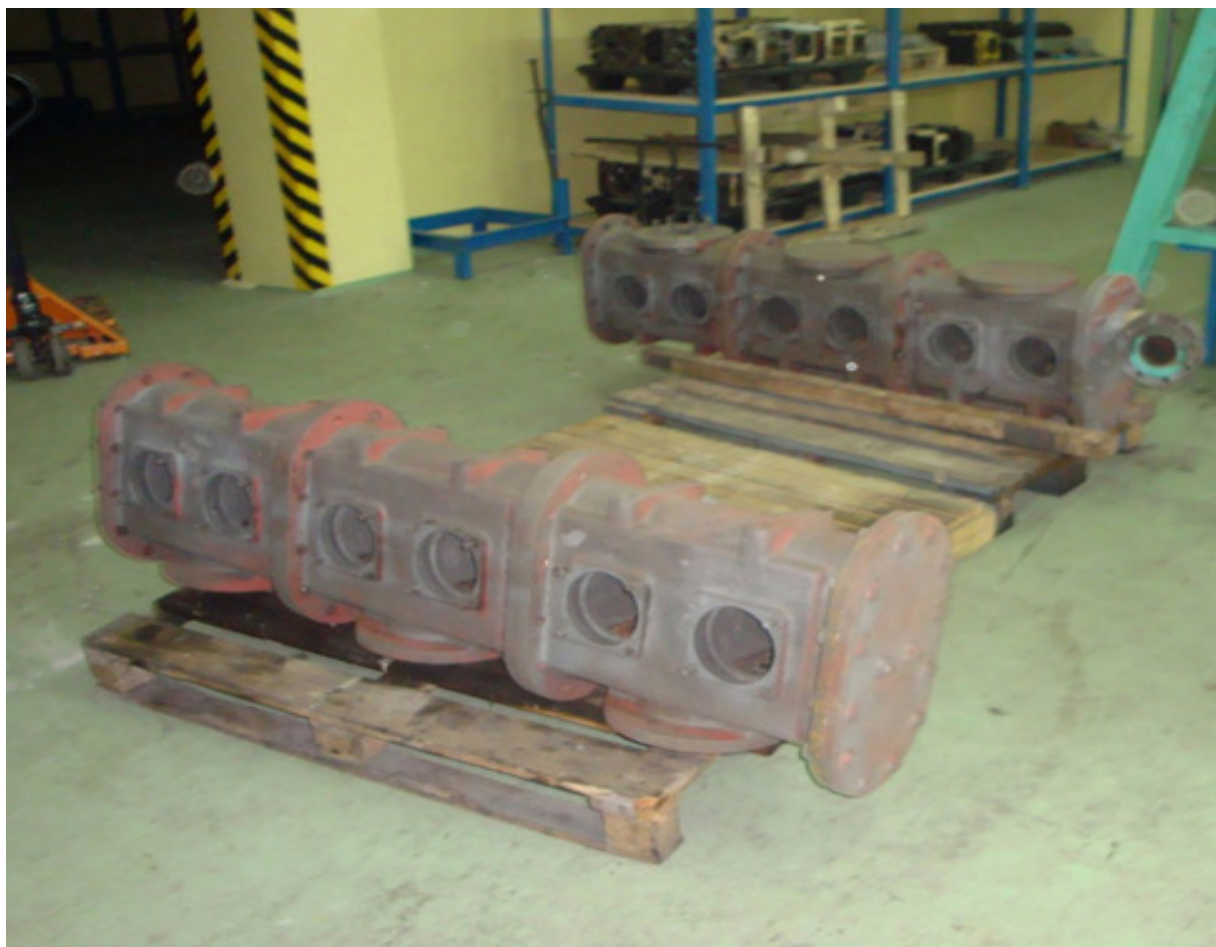
Application:	Ballast valve casings
Place:	Stettin, Poland
Date:	January 2009
Job and report done by:	Local workshop, Stettin and Wencon technician
Wencon products used:	Rapid, Release Agent, Cleaner, appl. tools

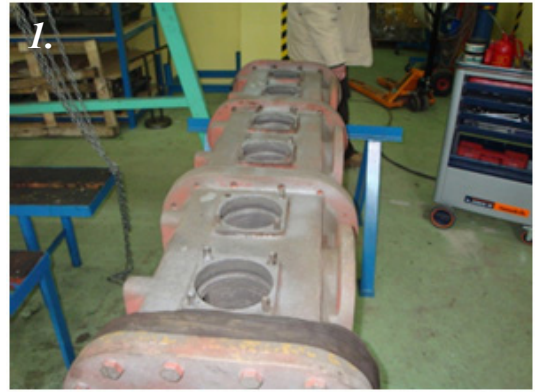
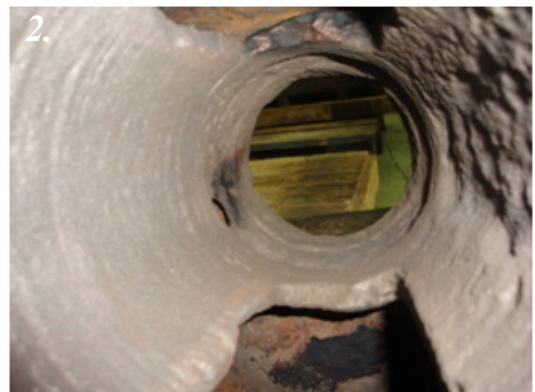
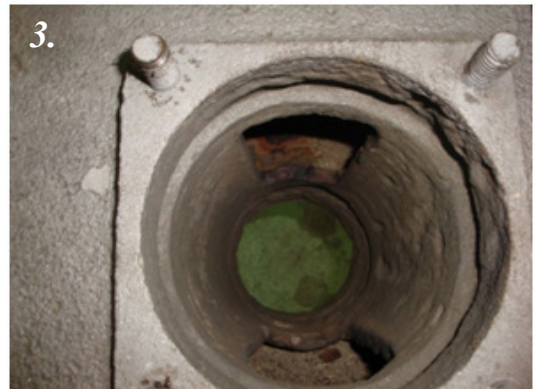
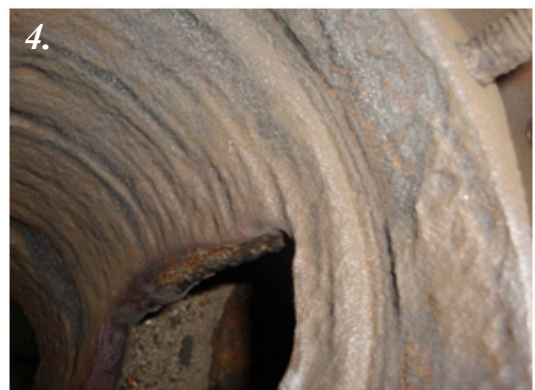
Then sandblasted again to avoid “new rust”.
