Main Propulsion Propeller Blades- cavitation damage

Job executing contractor: FA-Yard

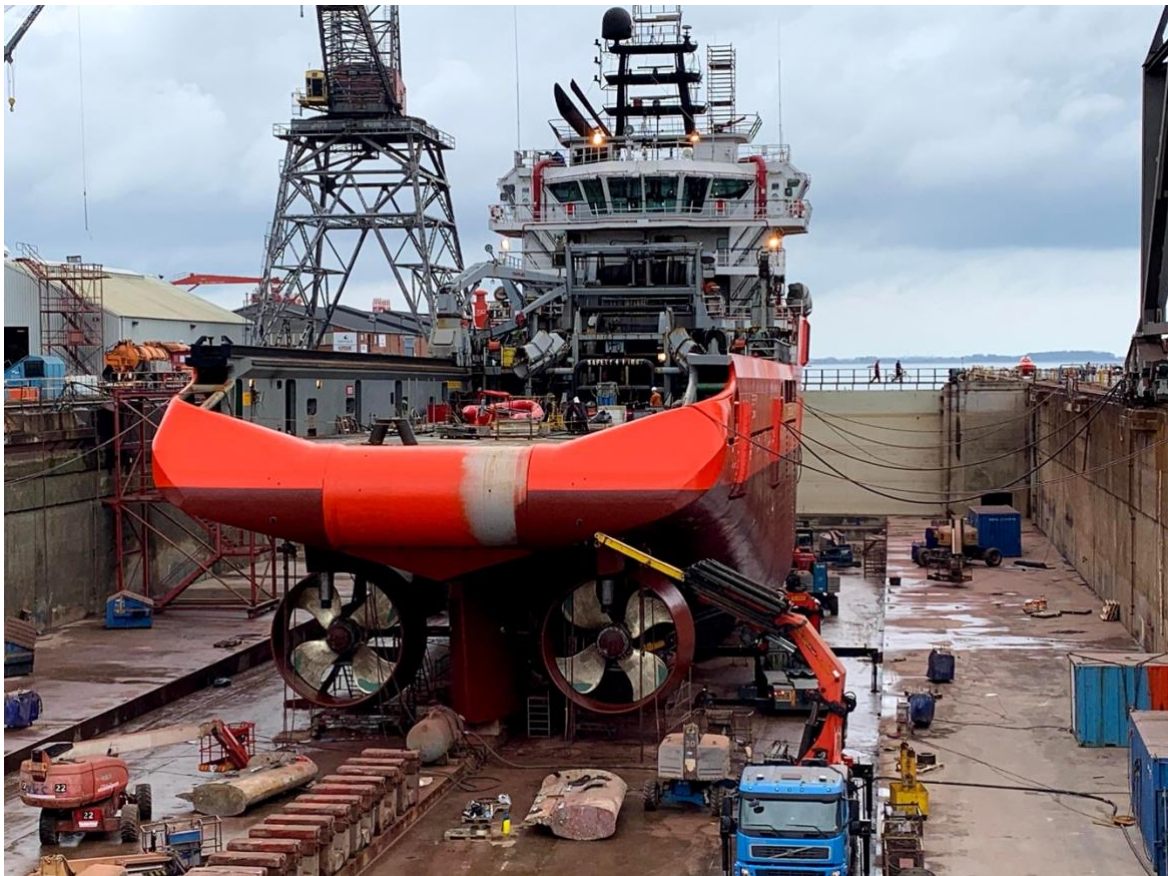
Main Propulsion Propeller Blades- cavitation damage

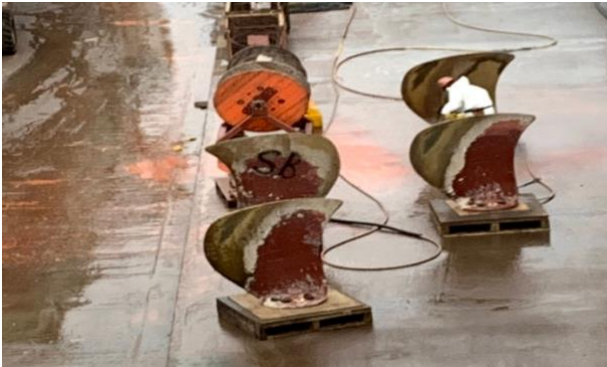
1. After disassembling the Propeller Blades, the surface is prepared using UHP Water Jetting to remove all salt and uncleaness's out if the metal surface.

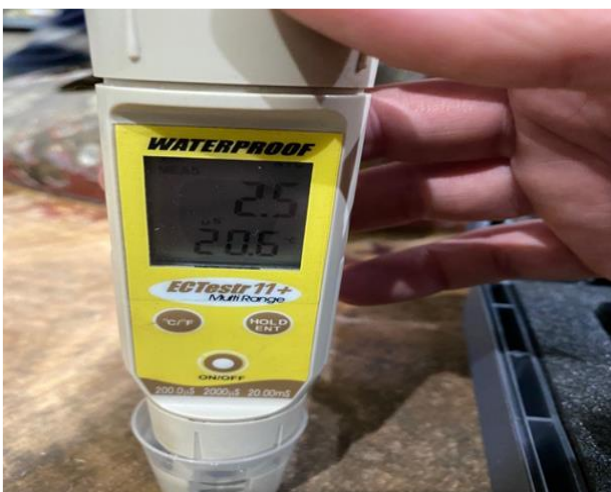
3. Measured salt content of the liquid before injection of the liquid into the patch – value 2.5 us/cm

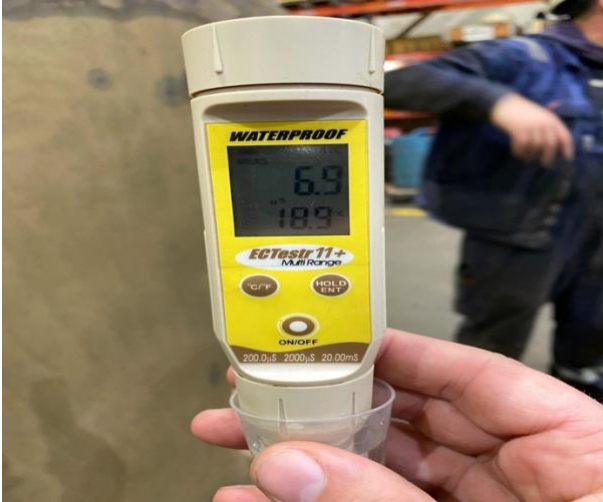
4. Measured salt content of the liquid after injection in patch x 5 times - value measured 6.9 us / cm

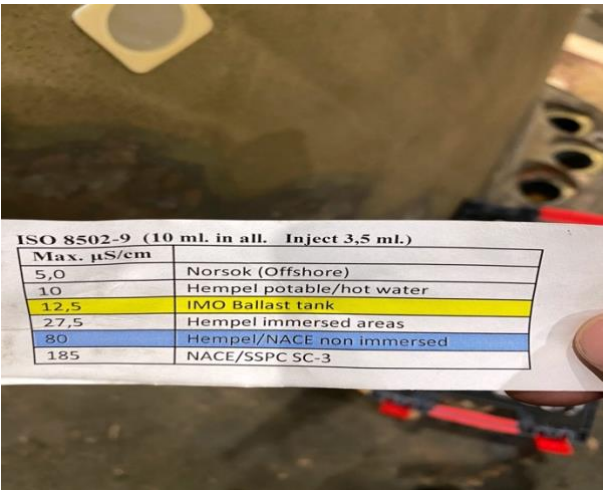
5. The final value: $2.5 - 6.9 = 4.4$ us/cm. According to the most common standards as seen on picture on the left, it will meet even the toughest standards.

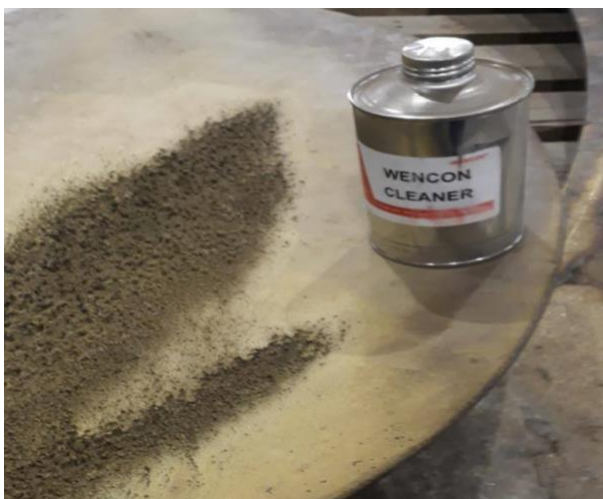
6. Due to the extent of cavitation and damage to the propeller blades, the surface is already rough and suitable for applying Wencon Ceramic Cream.

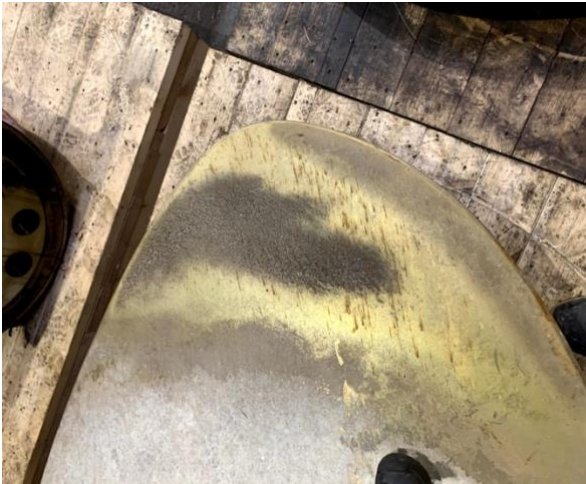
7. Cavitation damage on the Propeller Blade.

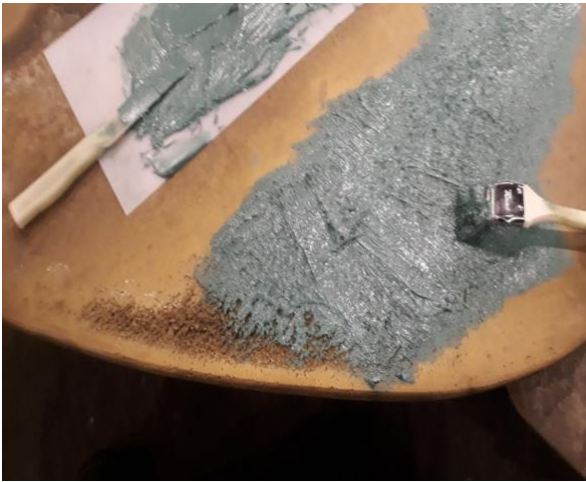
8. To optimize adhesion, the 1st layer Wencon Ceramic Cream are “worked toughly” into all pores and unevenness of the cavitated arias.

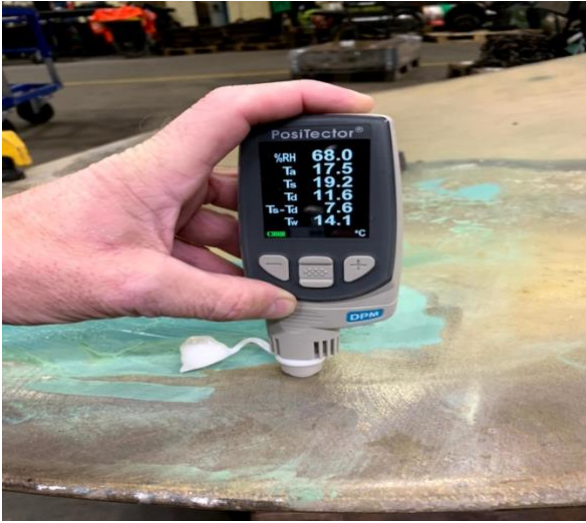
10. Throughout the complete application process, distance to the dew point is kept above 3°C to ensure a dry surface to be applied to.
