## Turbo charger housing water side

<b>Application:</b>	Rebuild and repair of leak at in-/outlet areas
<b>Place:</b>	France
<b>Date:</b>	April 2007
<b>Job and report done by:</b>	ETS Tiano & Wencon, Denmark
<b>Wencon products used:</b>	Hi-Temp Green, Cleaner, appl. tools

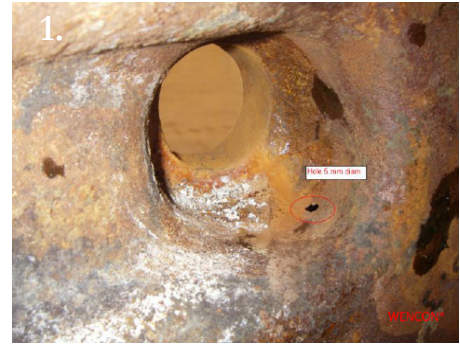
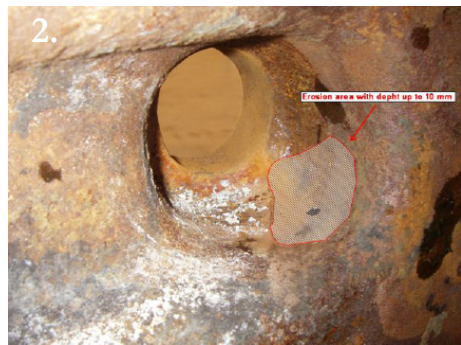
1.& 2.

5mm holes found at the in/out's and erosion areas, in about 10 mm depth.

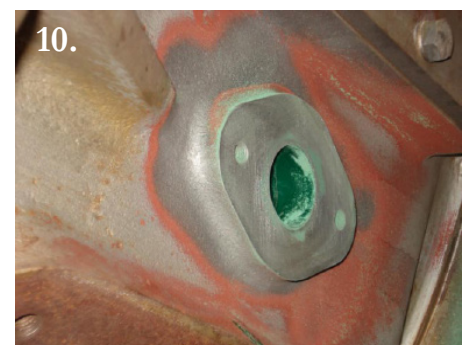
10. Final result.

Ready for many years of service again.
